Project Erebus Floating Offshore Wind Farm

Notice to Mariners

NtM Number	Erebus/003 v20.0
Date of Issue	03/12/2021

Recovery of Moorings

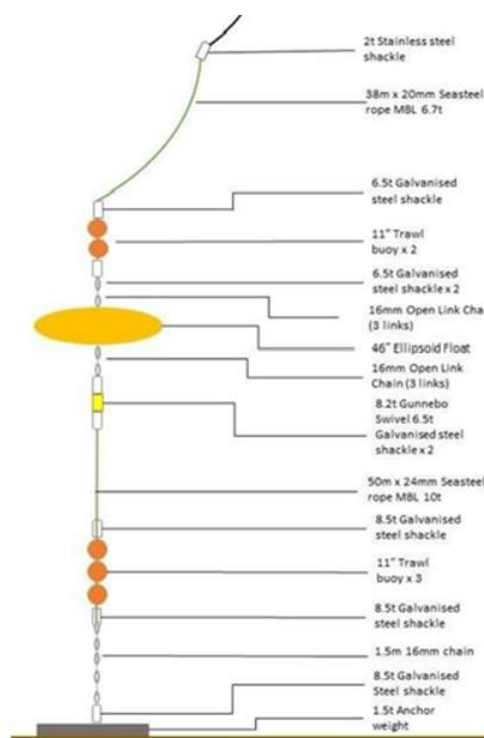
An image of the two mooring systems on the seabed is shown below. The first 15 m from the upper mooring has been recovered. The remaining mooring components start from the 38 mm x 20 mm seasteel to the anchor weight on the seabed.

A Remotely Operated Vehicle (ROV) will be deployed to identify the moorings. The moorings will then be brought to deck and transported to shore.
