Project Erebus Floating Offshore Wind Farm

Notice to Mariners

NtM Number	Erebus/003 v17.0
Date of Issue	23/09/2021

Recovery of the Moorings

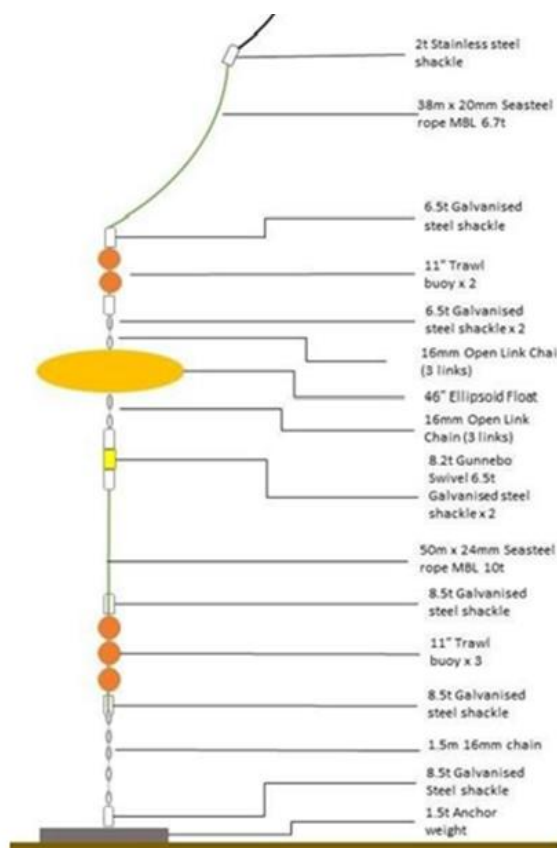
An image of the two mooring systems on the seabed is shown below. The first 15 m from the upper mooring has been recovered. The remaining mooring components start from the 38 mm x 20mm seasteel to the anchor weight on the seabed.
