Project Erebus Floating Offshore Wind Farm

Notice to Mariners

NtM Number	Erebus/003 v19.0
Date of Issue	28/10/2021

Recovery of the Moorings

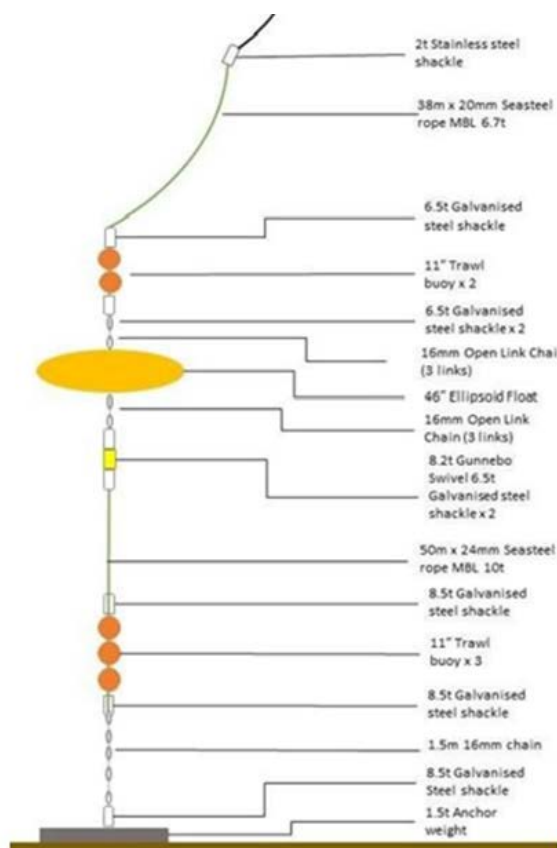
An image of the two mooring systems on the seabed is shown below. The first 15 m from the upper mooring has been recovered. The remaining mooring components start from the 38 mm x 20 mm seasteel to the anchor weight on the seabed.

A Remotely Operated Vehicle will be deployed to identify the moorings. The moorings will then be brought to deck and transported to shore.
